HISTORIC PRESERVATION COMMISSION AGENDA

HISTORIC ARCHITECTURAL DESIGN GUIDELINES

WASHINGTON PARK HISTORIC DISTRICT
BOROUGH OF NORTH PLAINFIELD, NEW JERSEY

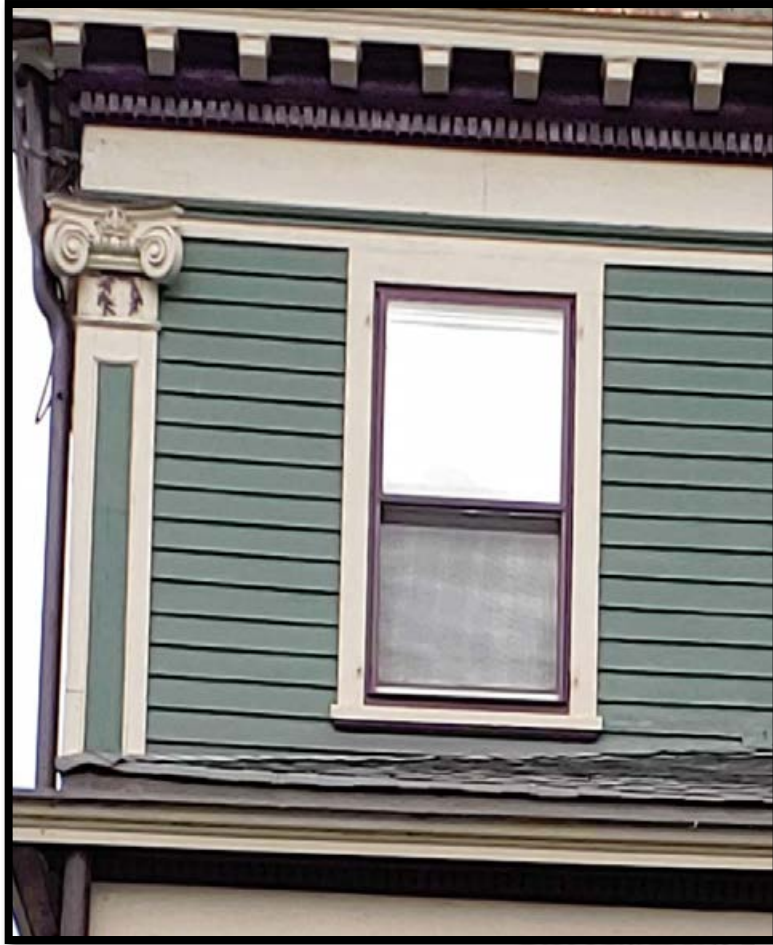
Appropriate Treatment

The siding applied in this example is wood clapboard similar to the original treatment. The window trim delineates the window from the wall surface. Corner posts are decorated with stylistically-appropriate Corinthian Capitals. The overall appearance is in keeping with the Romantic-inspired aesthetic originally intend-

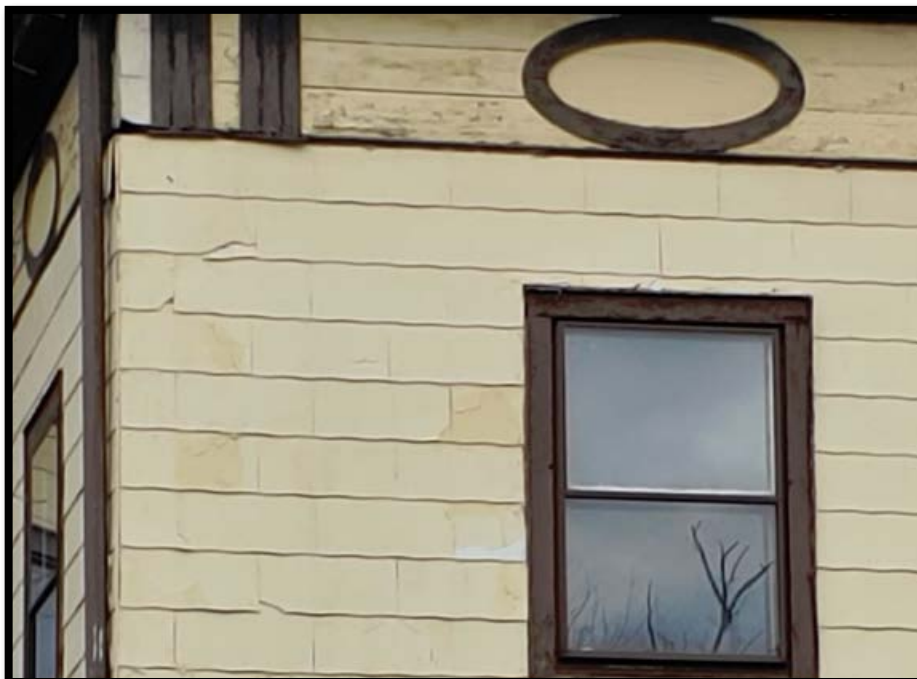
Inappropriate Treatment

The siding applied in this example is asbestos single with no applied corner posts. The window trim is sunken beneath the plane of the siding. Gone are the Romantic-inspired design elements now replaced with mid-twentieth century geometric design.

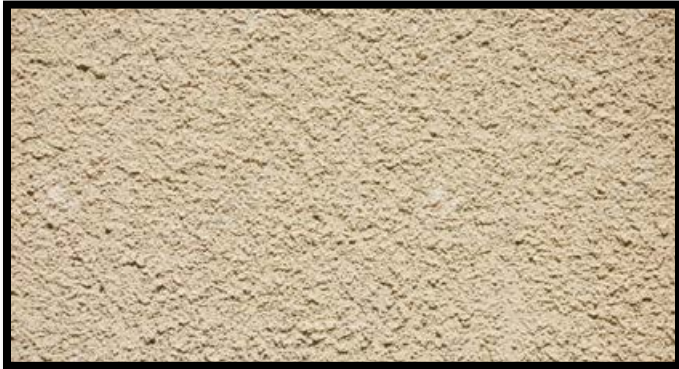
Historic Materials
Concrete and Stucco

Stucco is a type of exterior plaster historically used on brick buildings to seal masonry and sometimes scored to resemble stone. During the early twentieth century, stucco was also placed over wood or metal lath as an exterior wall surface. The use of concrete block became popular after 1900 as a foundation and exterior wall material. Foundations of poured concrete were common during this period as well.

Original stucco and concrete surfaces should be repaired as needed and maintained. The original texture of the stucco and concrete should be replicated when repair or replacement is needed. The replacement of stucco with an Exterior Insulation Finishing System (EIFS) is not appropriate for historic dwellings since the material does not resemble stucco and is prone to water damage.

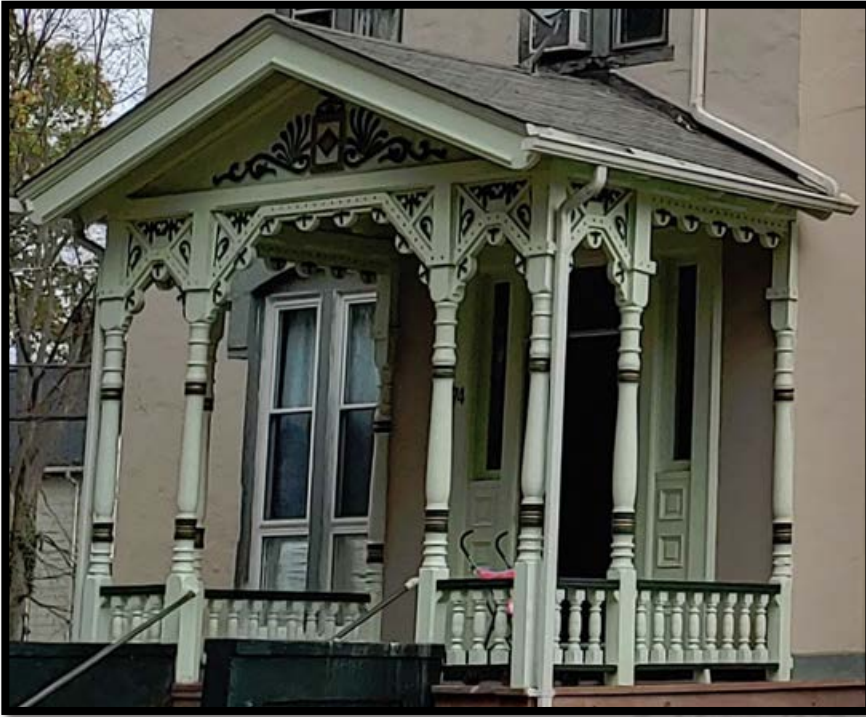
Appropriate Treatment

The turned posts, baluster, and scrollwork is maintained in accordance with the original design. Complementary paint colors are used to accentuate and add distinction.

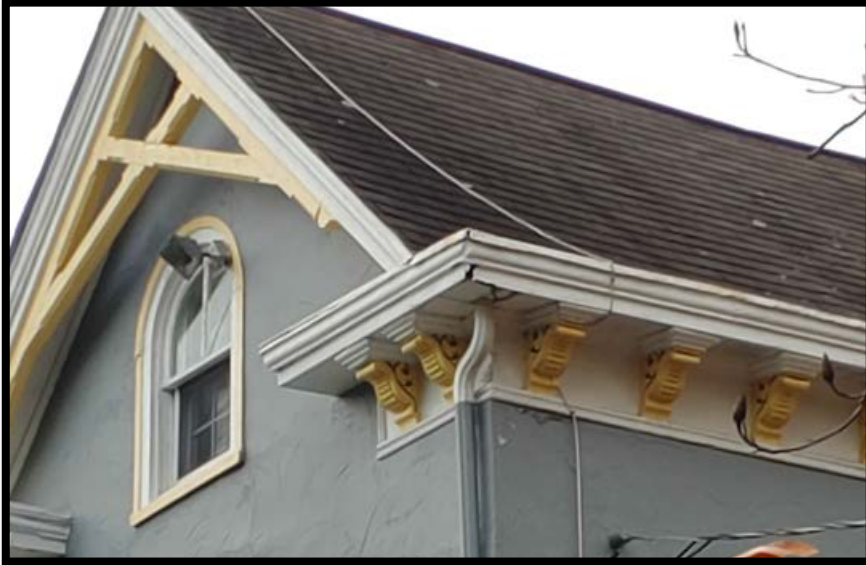
Inappropriate Treatment

Original posts, balusters, and decorative elements have been removed and the canopy has been converted into an extra room inconsistent with its original design and use. In addition, the aluminum fascia and vinyl siding are not compatible materials.

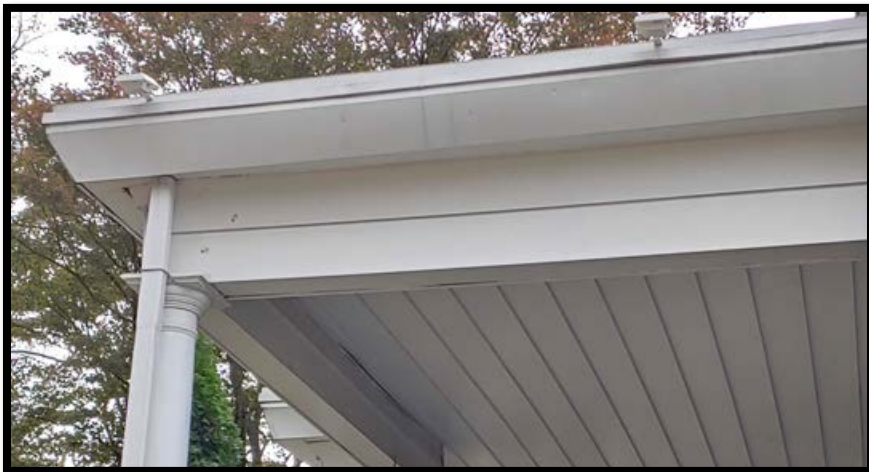
Appropriate Treatment

The gable-end truss, brackets, and overhang are preserved and maintained as originally designed.

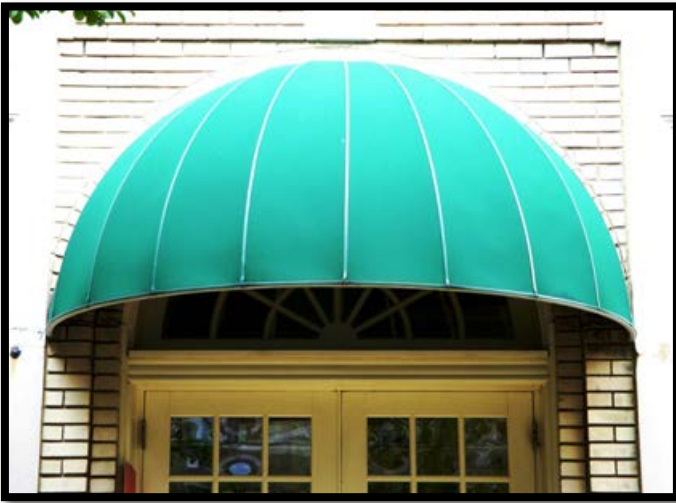
Canvas or fabric awnings were once common to provide shade for entrances, porches, and windows, especially on a sun-exposed elevation. Awnings declined in use after the mid-twentieth century when air conditioning units became widely available. Awnings are once again becoming popular to assist with energy conservation.

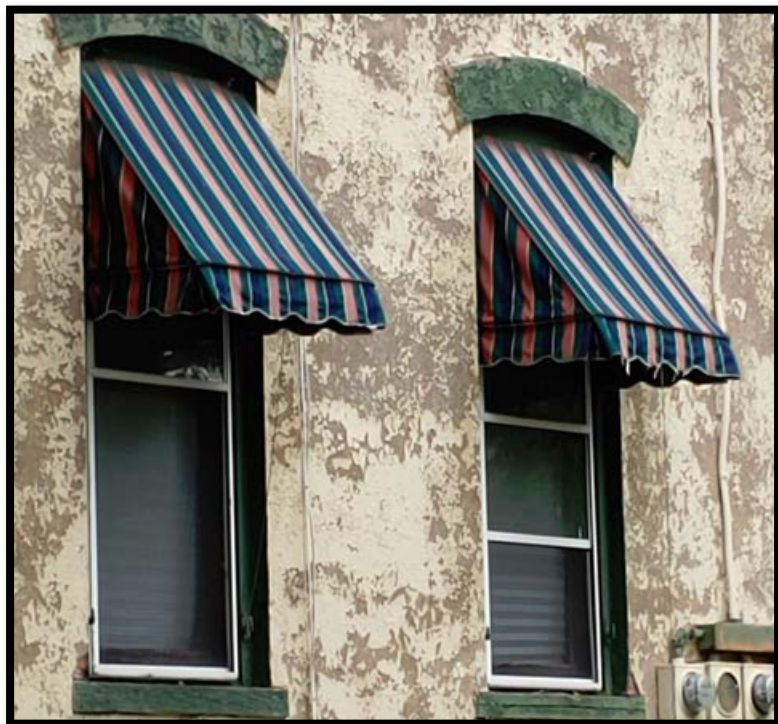
Appropriate Treatment

Canvas awnings are easily reversible, decorative, and leave visible the arched window surrounds.

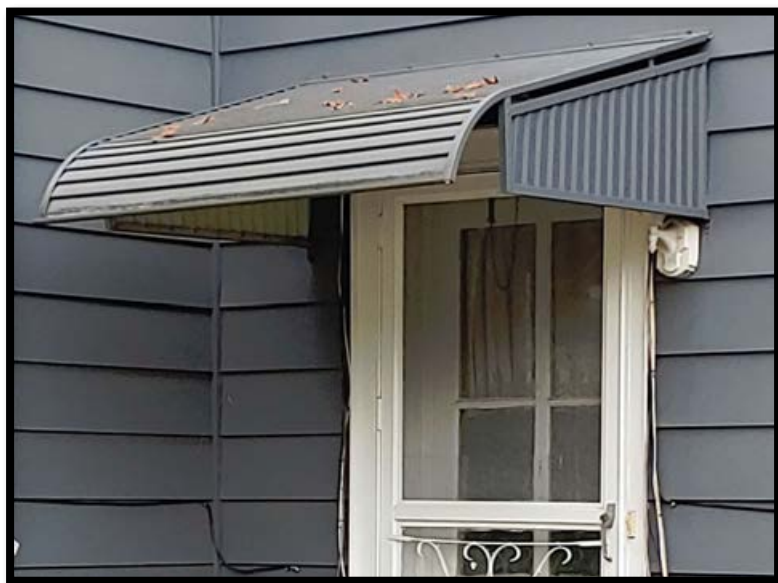
Inappropriate Treatment

The sheet metal awning is more permanent, not visually sympathetic to the building's design, and obscures the door surround.

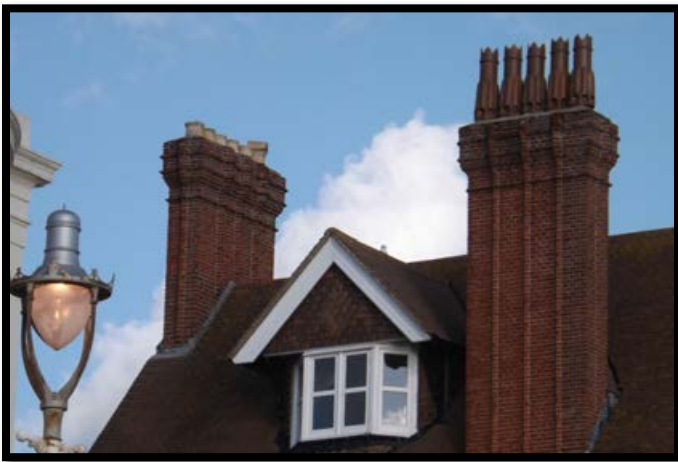
Chimneys often feature decorative brickwork or designs that contribute to a building's architectural character. On nineteenth century homes there may be decorative courses at the top of the chimney known as corbelling. Chimneys should be maintained and preserved in accordance with the appropriate brick and mortar guidelines.

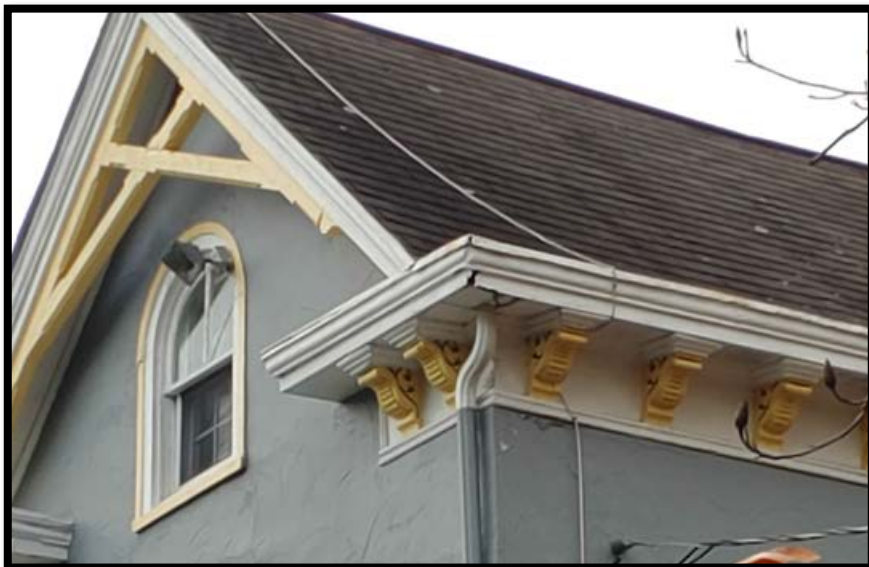
Appropriate Treatment

The gable-end truss, brackets, and overhang are preserved and maintained as originally designed.

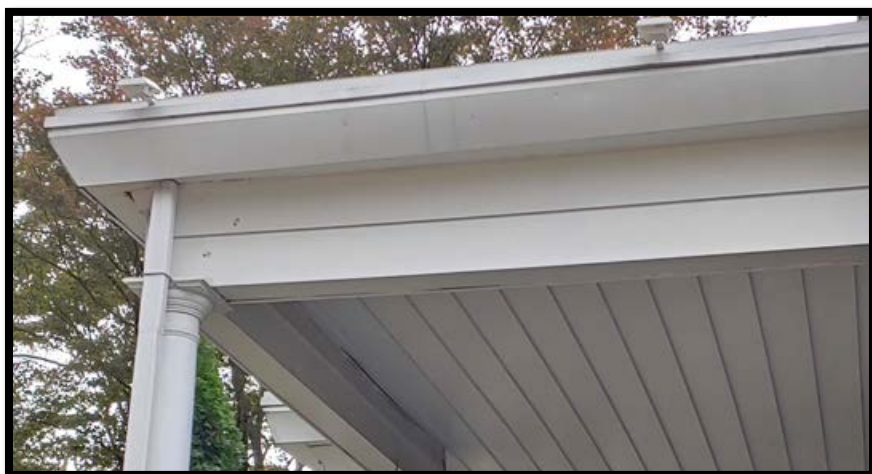
Inappropriate Treatment

The beams are aluminum-wrapped with a synthetic decorative column, and aluminum siding installed instead of a compatible soffit material.

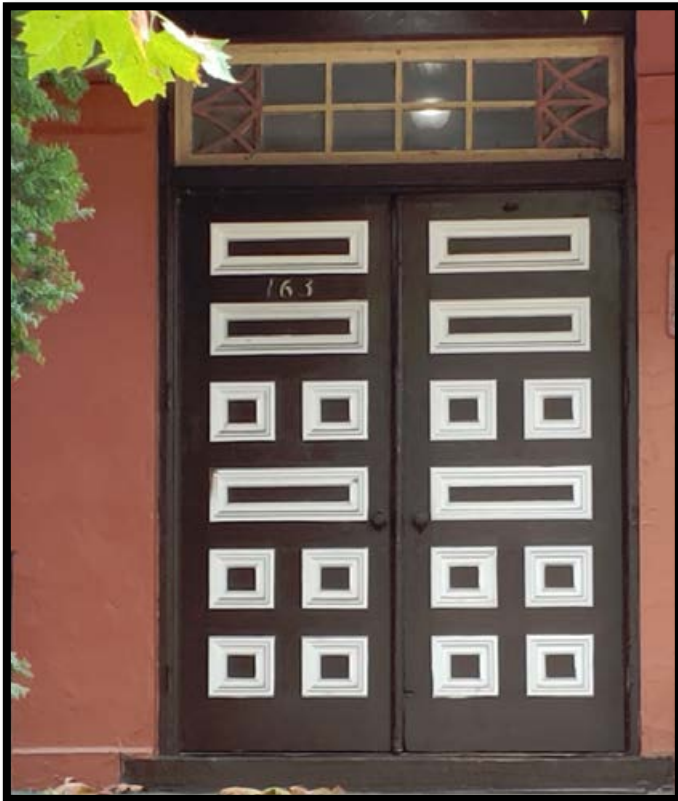
Appropriate Treatment

The wood door and transom light are original and reflect the design-aesthetic initially intended. In addition, the elements have been well-maintained.

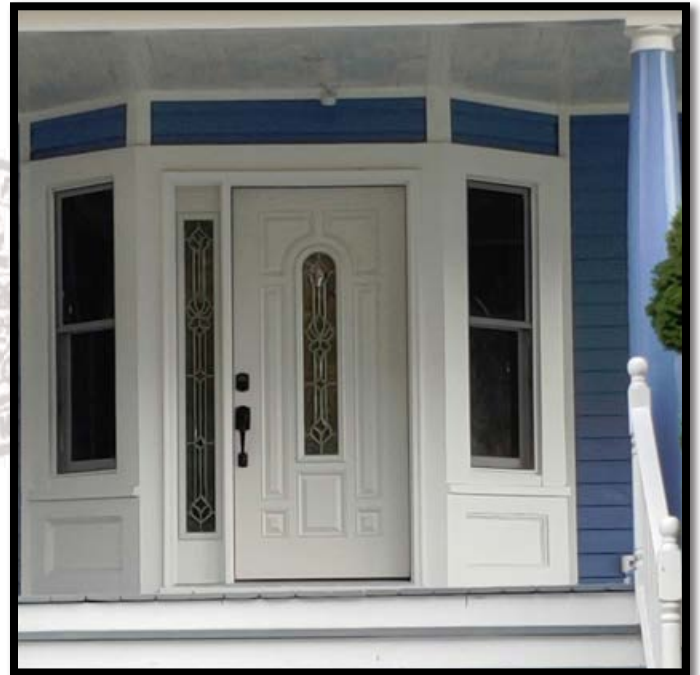
Inappropriate Treatment

The original front door has been removed and replaced with a modern fiberglass door exhibiting a decorative sidelight. The style of door and sidelight are not consistent with the initial design or historically appropriate.

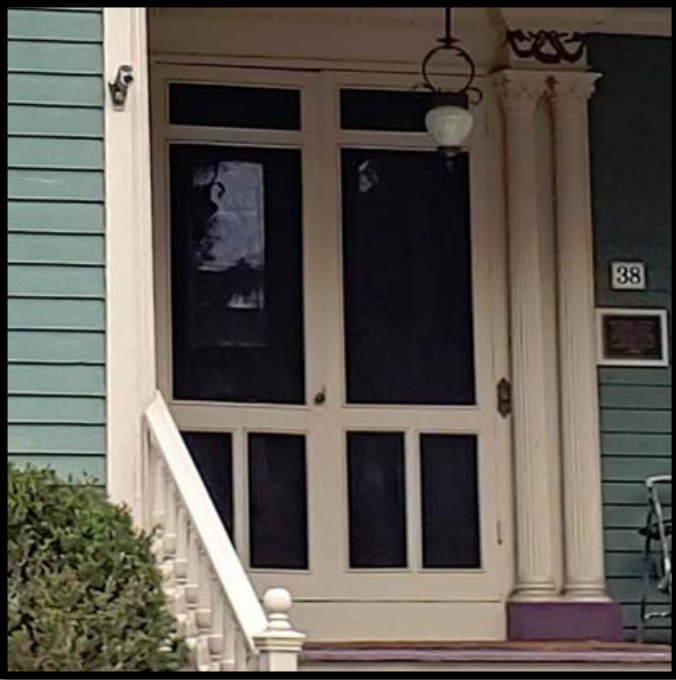
Appropriate Treatment

Screen door has a minimal frame and is made of a material that allows full view of the door behind.

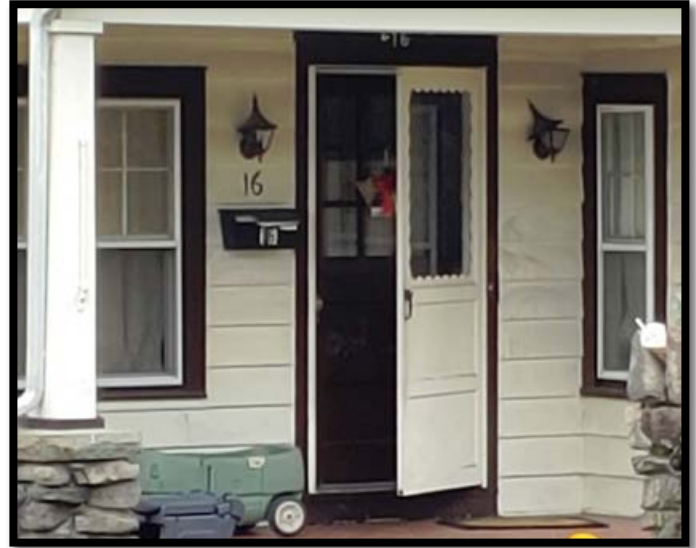
Inappropriate Treatment

Screen door is largely solid and blocks view of the original four-light wooden door behind.

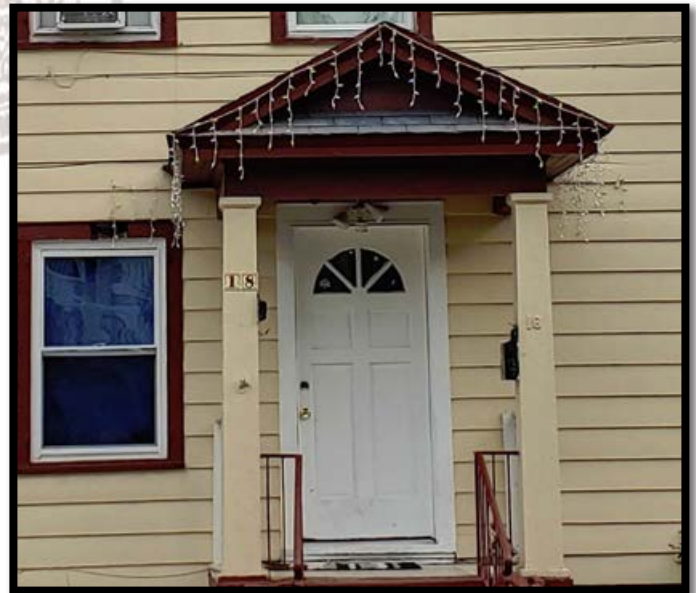
Inappropriate Treatment

The original entry door has been removed and replaced with a metal-clad entry door with modern fanlight design.

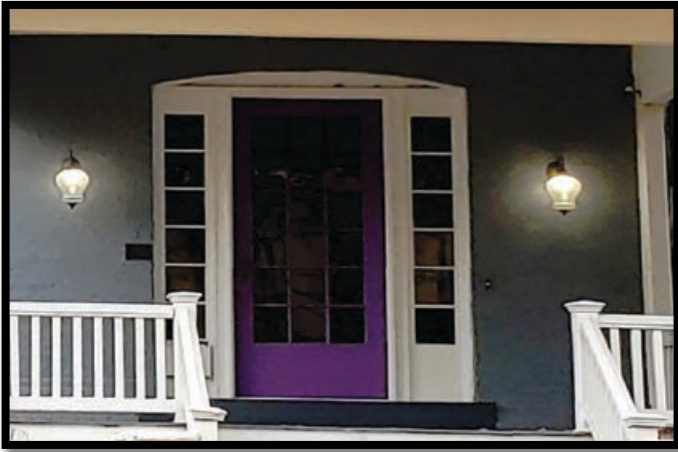
Appropriate Treatment

Entry door is original and well-maintained with appropriate matching sidelights.

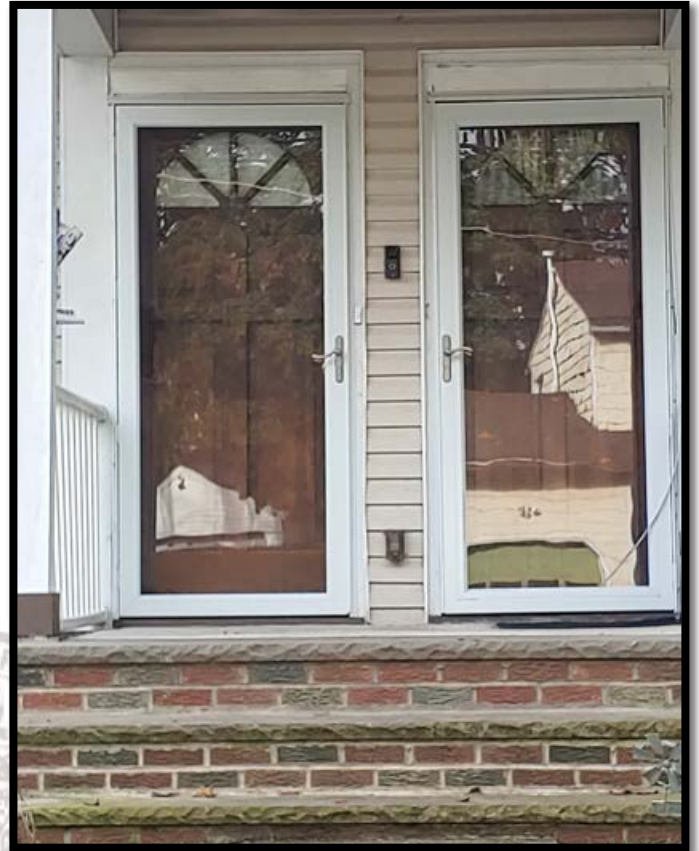
Inappropriate Treatment

Both screen and entry doors are inappropriate for the design and age of the home. Screen doors are intrusive, of a different color from the entry, and distract attention away from the original entry door.

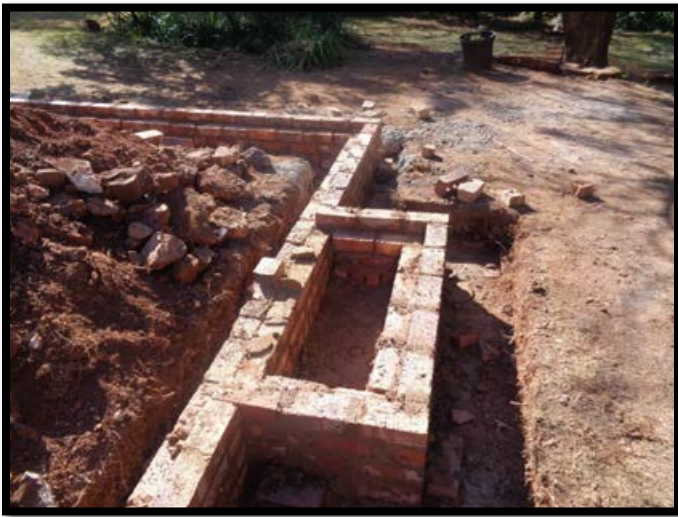
Most dwellings in Washington Park have foundations of brick or brick piers. In some cases these foundations were of solid brick with vent openings while others had wood or brick lattice panels between piers. By the early twentieth century, foundation materials varied with poured concrete or concrete block widely used. The foundation materials and their designs are important components in the style and design of a dwelling.

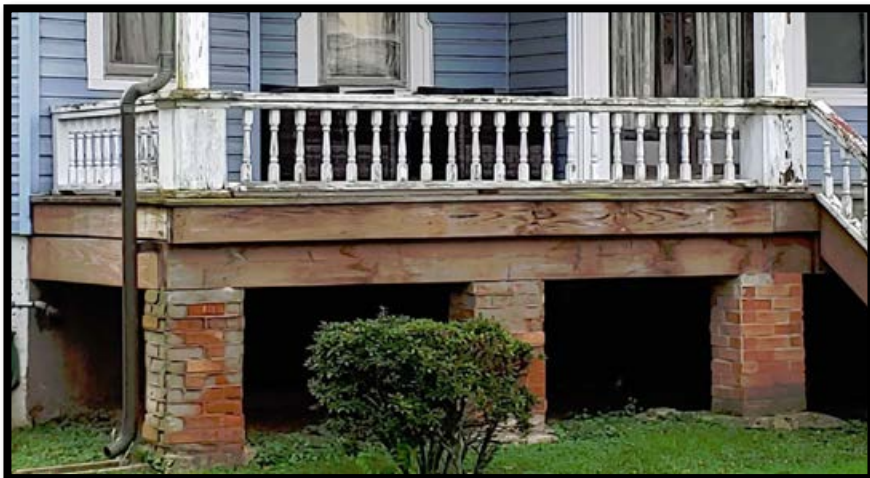
Appropriate Treatment

The brick foundation piers are exposed and visible.

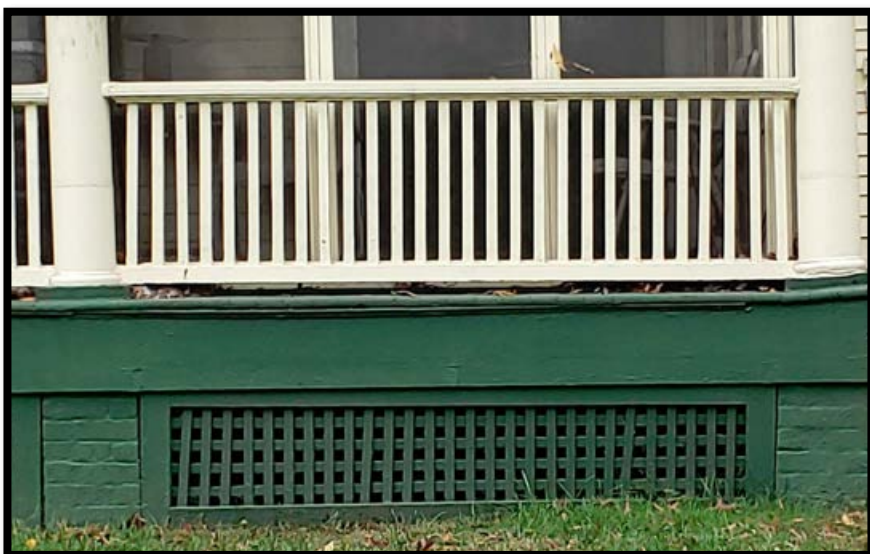
Appropriate Treatment

The brick foundation piers are exposed with wood lattice in-fill panels.

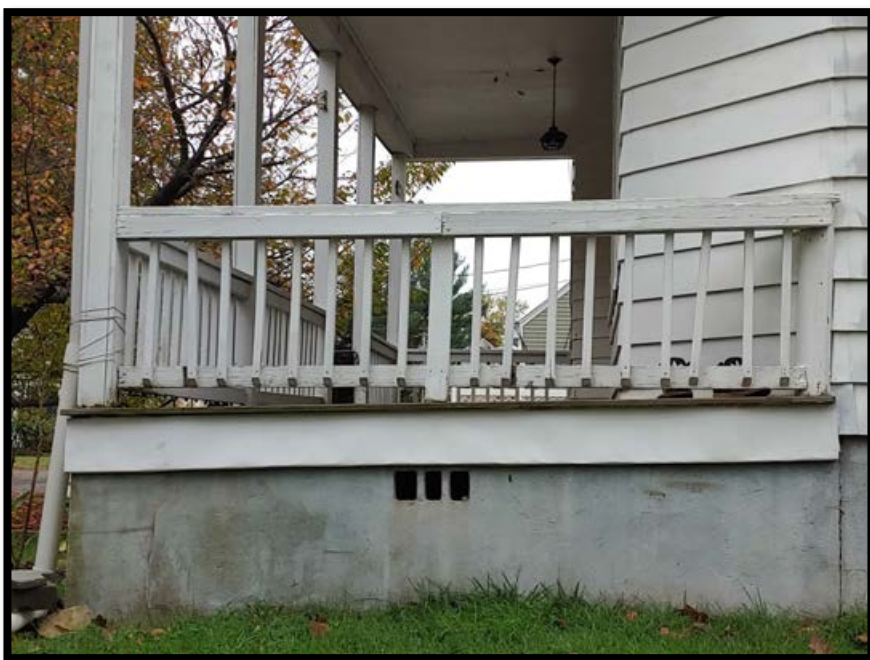
Inappropriate Treatment

Concrete block infills between the brick foundation piers and the whole foundation is covered with cement parging.

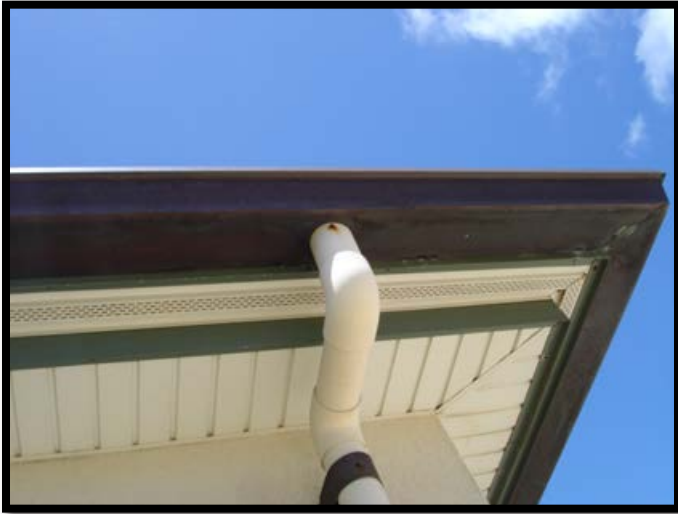
Most of Washington Park's dwellings were built with various types of gutter and downspouts. Gutters were originally made from dense woods such as cedar or molded metal panels. More ornate homes had "box gutters" which are metal-lined wooden boxes built into the eaves of a house. By the late nineteenth century, wood and metal gutters became more widespread and half-round designs were widely used. Today, "K" crimped gutters are also widely available.
